Service Bulletin

SAFETY RECALL

2002-2003 GL1800 BANK ANGLE SENSOR MOUNTING SCREWS

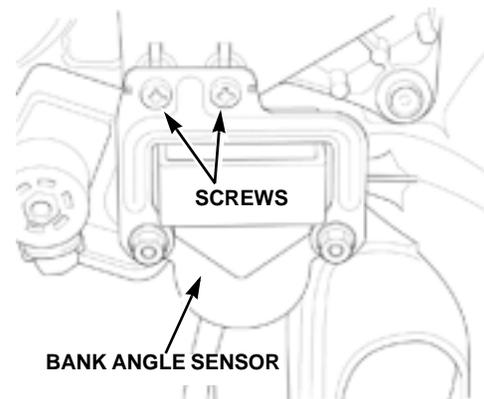
On affected units, the bank angle sensor was installed incorrectly at the factory with 4 mm screws instead of the specified 5 mm screws. The incorrect fasteners will not hold the sensor, and it can eventually detach from its mounting point. If the sensor is not held in an upright position, the engine will stop unexpectedly. Sudden loss of engine power, especially while turning, may cause a crash.

3. To check for the proper screw size, slightly tighten both bank angle sensor screws. If the screws are tight, reassemble the unit and apply the identification mark. If the screws spin in the holes, proceed to Step 4.
4. Using a magnetic screwdriver, remove and discard one of the two 4 mm screws securing the bank angle sensor assembly. Replace with a 5 x 12 mm self-tapping screw (see the PARTS INFORMATION section on page 3 for the proper screw for this repair). Repeat for the other screw.
