# Service Bulletin

American Honda Motor Co., Inc.

## 2001-2008 GL1800 Trunk Opener Unit, Opener Rod & Snap

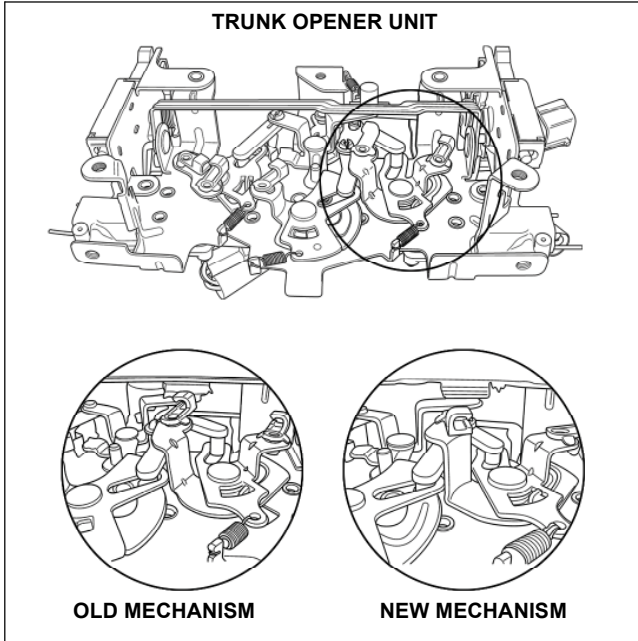
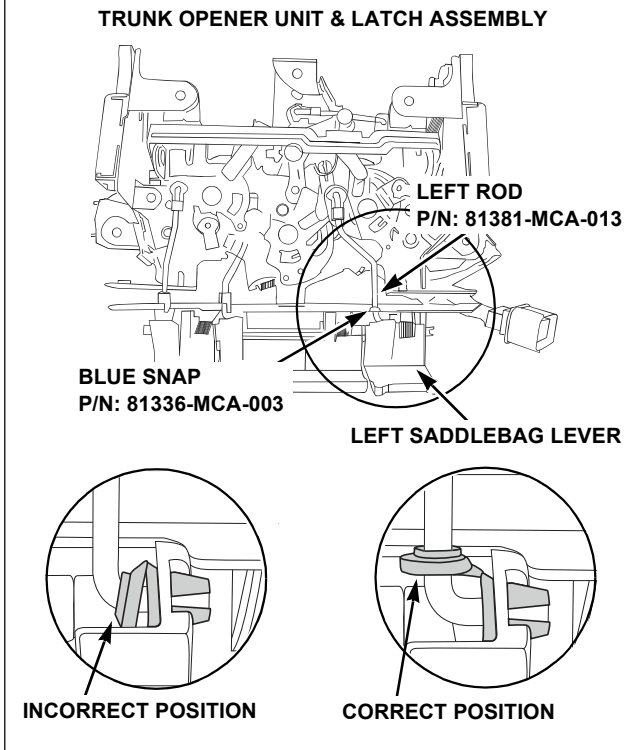
**PARTS DESCRIPTION**

During production for the 2008 model year, the trunk opener unit was modified with a new, redesigned left opener rod (which runs from the opener latch lever to the opener body) and a new blue snap (which fastens the rod to the latch lever). The blue snap replaces a green snap that may experience breakage.

**New Opener Rod & Blue Snap:** After placing the rod through the snap, be sure to move the hinged portion of the snap around the L-shape of the rod to avoid possible function loss. See the illustrations on page 2.
