Service Bulletin

SAFETY RECALL

2002-2004 GL1800/A

Linked Braking System (LBS) Proportional Control Valve (PCV) Leakage

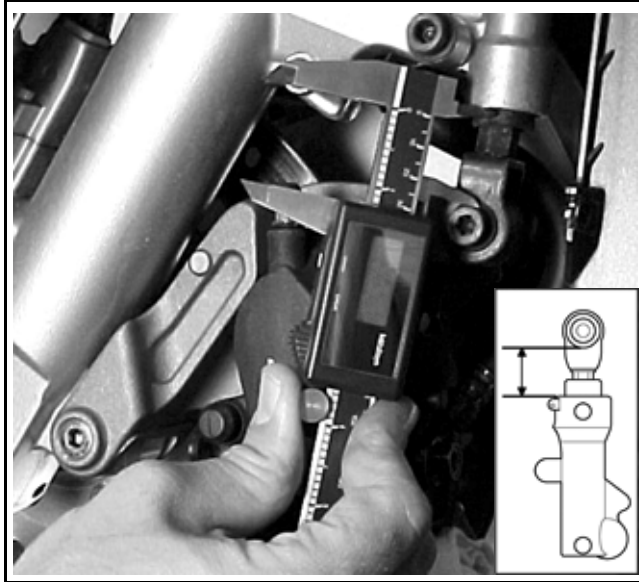
- If the measurement has **decreased more than 1 mm** from the measurement you recorded, proceed to step 7 below.
- If the measurement is within **1 mm** of the measurement you recorded, the PCV is OK. Proceed to the IDENTIFICATION section of this Service Bulletin.

6. Measure the distance again from the secondary master cylinder piston mounting bolt to the edge of the secondary master cylinder body (rod length of the secondary master cylinder).

7. Check the PCV for leakage.

- **If the PCV is leaking**, replace the PCV per the Service Manual. After replacing the PCV, proceed to the IDENTIFICATION section of this Service Bulletin.
- **If the PCV is not leaking**, you must diagnose the brake system problem before proceeding.
