Service Bulletin

SAFETY RECALL

2003-2004 GL1800/A

Frame Weld

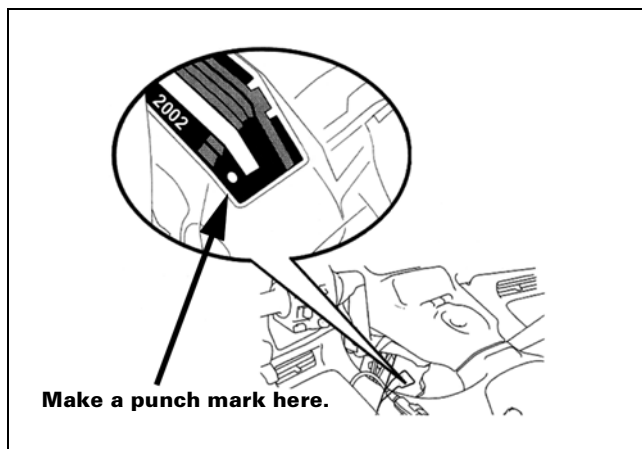
After you have completed the disassembly, welding, painting, and re-assembly procedures, make a punch mark on the lower right hand corner of the VIN plate, as shown below.

If there is a punch mark on the VIN plate as specified in this Service Bulletin, the unit has been repaired and no further action is required.

If there is no punch mark on the VIN plate as specified in this Service Bulletin, proceed to the REPAIR PROCEDURE section of this Service Bulletin.
